### **Engineering a Safer & More Accessible Alton**

Spring 2019 • Civil Engineering 493 • Civil Engineering Senior Design Class

SIUE Successful Communities Collaborative Year 2018-2019

City of Alton, Illinois

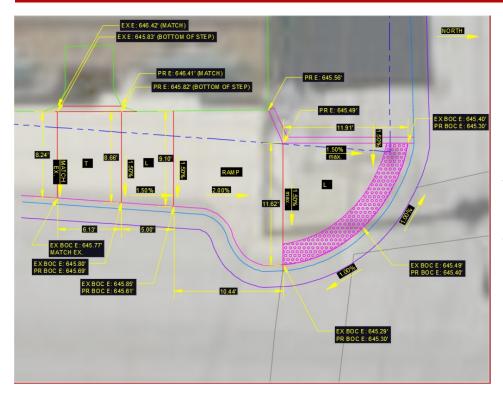
Figure 2: Ramp #1

Ramp #1: The existing conditions of this curb ramp contained no detectable warnings and had a 2" high ledge at the edge of pavement. To solve this issue, the final design includes the curb declining with the sidewalk and a detectable warning placed in front of the curb ramp (Figure 2).

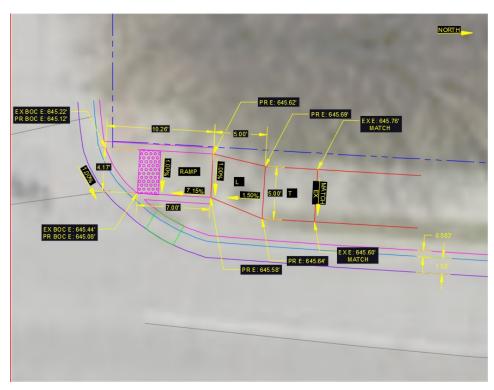
Figure 3: Ramp #2

Ramp #2: The detectible warning on this curb ramp has deteriorated and needs to be replaced. The sidewalk curves around an existing sewer inlet. This inlet will be replaced. The new design includes a narrow curb ramp to avoid buying property and a sidewalk placement that incorporates room for a new drainage inlet to the east (Figure 3).

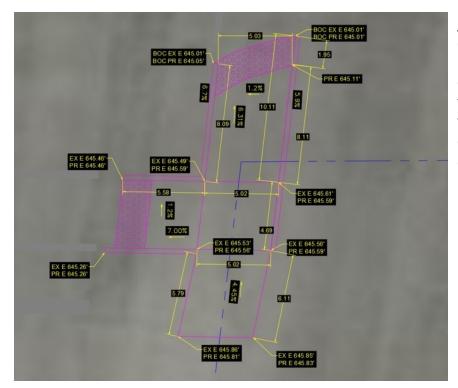
Figure 7: Ramp #6

Ramp #6: There is no existing ramp at the corner intersection. A depressed corner design that ramps up to both sidewalks leading up to it is used so that the corner is wheelchair accessible (Figure 7).

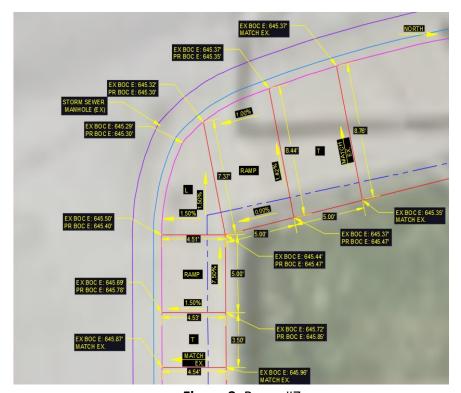
Figure 8: Ramp #7

Ramp #7: The ramp does not have a lower landing pad for wheelchairs to safely stop before the road. This ramp was redesigned to have a two perpendicular curb ramps for the crosswalks crossing Delmar Avenue and State Street. The storm inlet will be removed, and the crosswalks will be realigned (Figure 8).

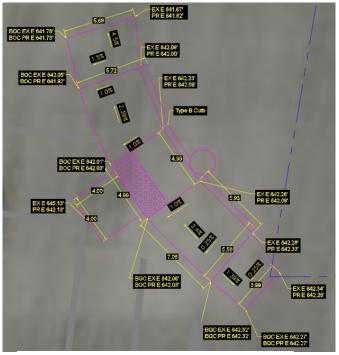
Figure 9: Ramp #8

Ramp #8: The existing ramp design currently does not include a landing pad, which is necessary for wheelchairs to be able to safely change direction and turn a 180° angle. The design of a corner parallel curb ramp is used to allow more room for the 4 feet by 4 feet landing pad. Type B curbing will be used for the backside, opposite side of pavement, of the sidewalk (Figure 9).

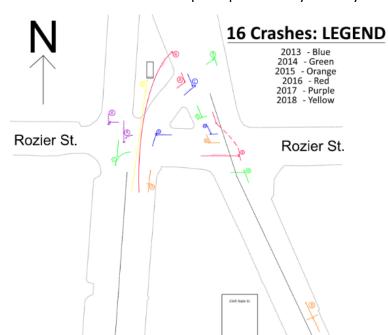
Figure 11: MicroStation Crash Diagram

A MicroStation file was completed by the team to more easily see the locations and causes of the crashes based on data provided by Mr. Caffey. Sixteen crashes were recorded from 2013 - 2018. The crashes are color coordinated by year, with the legend shown in the top-right corner of the sketch. For example, four green conflicts indicate four crashes in 2014 (Figure 11). Each crash site shows the path of each vehicle before the conflict and has its corresponding crash rating and the date it occurred, as shown in the example of the enlarged crash site (Figure 12). The highest crash rates occur in the areas of crossing Rozier St. from Belle St. and State St. and the T-intersection from South State Street that leads to North State Street and South Belle Street. The type of crashes with the highest frequency are T-bone collisions in which one vehicle makes a head-on collision with the side of another vehicle. A pattern can be seen in T-bone crashes as the vehicles on the streets with heavier volume get hit by the vehicles on the streets with lesser volume. There were two instances where a vehicle failed to stop at the Rozier Street intersection going north-bound on State Street. These vehicles collided with objects in the median which resulted in damage to a single vehicle each time.

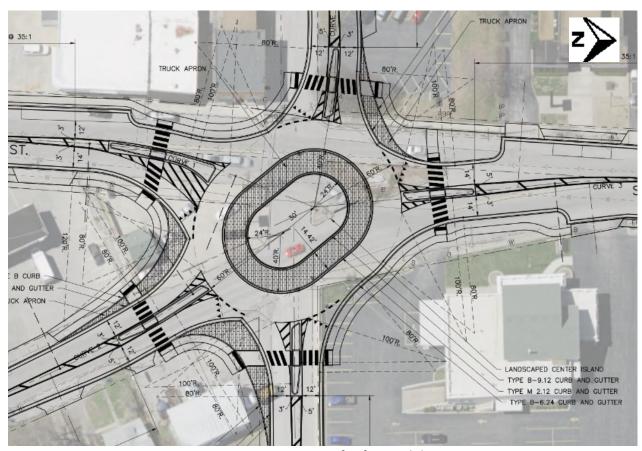
Figure 13: Design Draft of Roundabout

The design of the roundabout began as a traditional sketch. Specific problems became apparent from the initial design. For example, the traditional roundabout design would require several building demolitions and private property excavations due to its wide parameters. These factors would decrease likelihood of acquiring funding and increase the overall cost of the improvement.

The traditional roundabout was maneuvered to alternate locations, yet it always interfered with existing buildings and private property. In addition, the entrance/exit locations of State St. and Belle St. on the southernmost side of the roundabout were so close in location throughout this movement procedure that their entrance/exit locations molded into one large entrance/exit. This geometric conflict would lead to future issues in traffic flow and safety. With these problems in mind, the geometry of the roundabout was changed to an elliptical shape. This design would allow for the increase in distance between the State St. and Belle St. entrance/exit locations. In addition, the elliptical shape allows for the avoidance of building excavation, decreasing cost of the improvement. The redesigned roundabout requires City acquisition of small portion of a used car lot on the southernmost tip of the roundabout (Figure 13). The car lot can be purchased at a much lower cost than the cost of demolition and excavation of existing buildings and purchase of private property required by a traditional roundabout. The final conceptual design is shown (Figure 13).

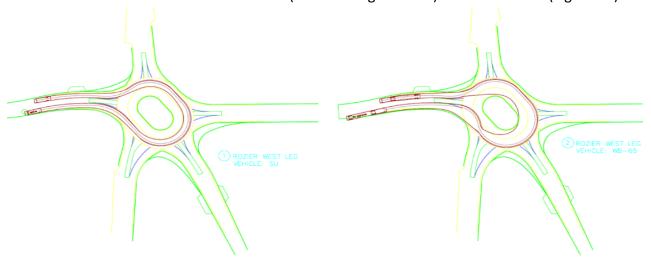
Figure 14: Offtracking of WB-65 Interstate Semitrailer Design Vehicle

The team also moved the roundabout to the southern direction of the intersection, giving a wider radius for an Interstate Semitrailer (WB-65 design vehicle) to make its turn (Figure 14).

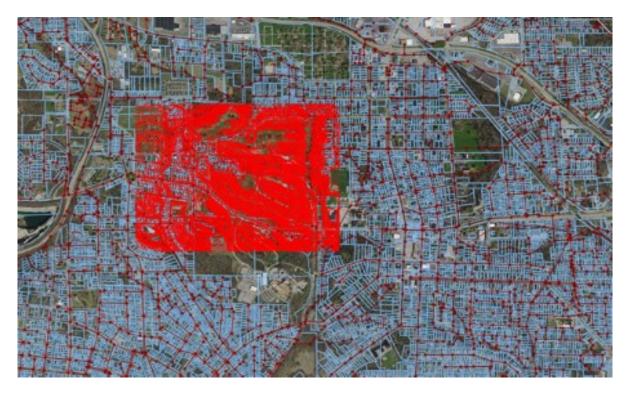
Figure 20: All previous maps combined and coordinates matched

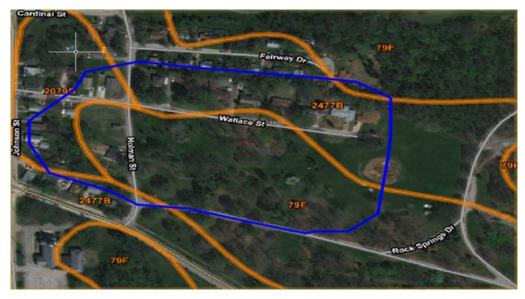
Figure 22: Rough area of watershed and soil map provided by USDA website

Runoff areas were defined by the combined efforts of our group and Justin Kleinschmidt, P.E., from SMS Engineering. In order to perform a pre- and post-analysis for the drainage basin, theoretical structures were added into the surrounding environment to better offset peak hourly flows. Directly to the north of the drainage basin was theoretical placement of commercial property for the post-development analysis. This addition caused more runoff from uphill to be directed and to pass through the basin located at a lower elevation. To the northeast of the commercial property line was a theoretical parking lot located next to a preexisting baseball diamond commonly used by the public. Additionally, pre-existing residential properties with a small creek running through them, which leads to the proposed basin, are located to the west. These features, in conjunction with a roadway located south of the basin, allowed water to flow down into the wet bottom basin. The elevations and key features helped define runoff areas in order to better assess the volume of rain runoff. The next step was to visit the USDA website and obtain a soils report. This report allowed us to determine the soils type of each area. Determining the soil types was key to finding out the weighted curve number, which we used in determining runoff volume. Figure 22 shows the watershed area and soil sections in relation to the design plans.

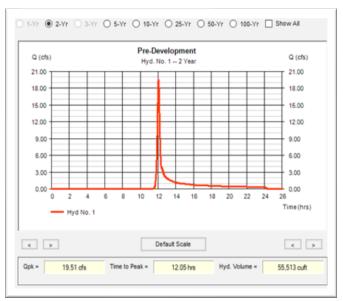
**Figure 23**: Hydrograph for our pre-development 2-year storm situation.

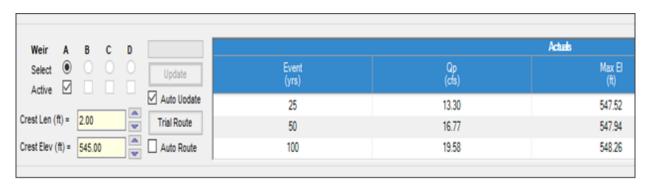
Figure 24: Designing the weir with adjusted the crest length.

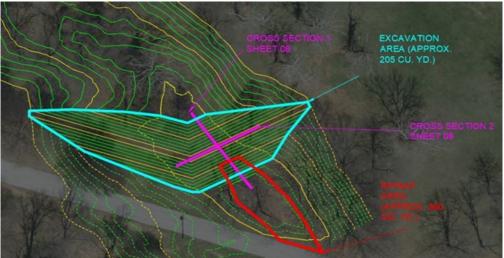
**Figure 26:** The final engineering decisions and site plan for the basin and dam design

Once the needed area of the basin was calculated, the team was then able to prepare site plans. Within AutoCAD the team edited existing terrain to show how the new dam would affect the surrounding elevation for the proposed wet bottom basin. Additionally, side and front views of the weir system were drawn using the same software to better illustrate the final look
